2018 Aquatic Vegetation Survey Report

Sherwood Forest Lakes

Becket, Massachusetts

Prepared by: SOLitude Lake Management
590 Lake Street
Shrewsbury, MA 01545

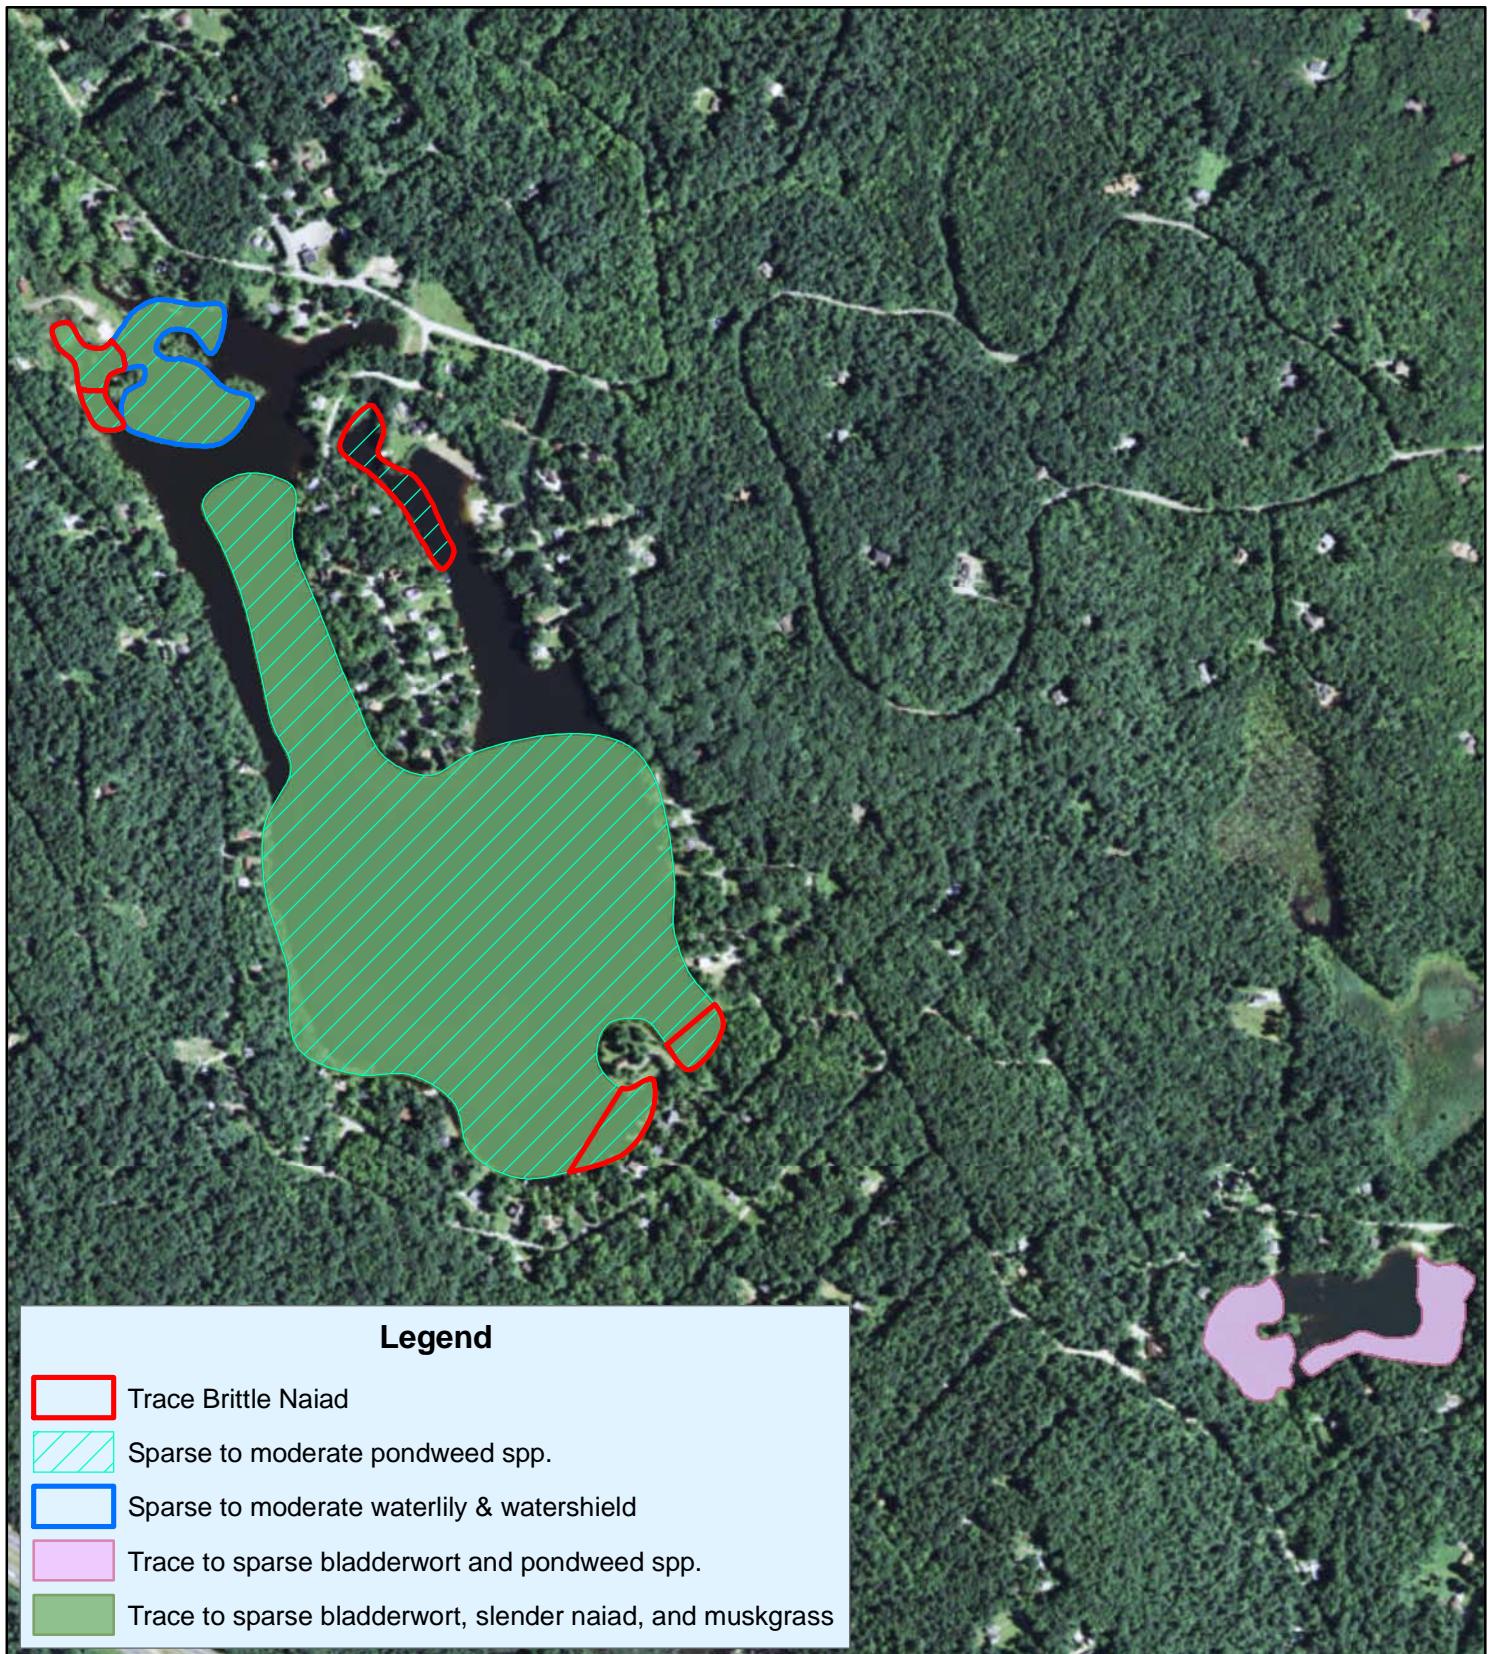
Figure 1: Pre-Management Distribution of Aquatic Vegetation

Pre: Sparse to moderate density large-leaf pondweed, sparse watershield and ribbon-leaf pondweed were common along the northern shoreline between the islands and beach area, along the eastern shoreline and in the two shallow coves at the southern end of the lake. Scattered occurrences of bladderwort, tapegrass, and snail-seed pondweed were also recorded. An interim survey was conducted on July 9th to determine treatment areas for brittle naiad, as this is a warm water species which emerges in the latter portion of the growing season.

Pre: Sparse bladderwort and muskgrass were common along the northern and western shoreline. Low-densities of native low-watermilfoil, large-leaf pondweed and muskgrass were present scattered along the island and eastern shoreline. Minor occurrences of ribbon-leaf pondweed were present along the island and immediate shoreline.

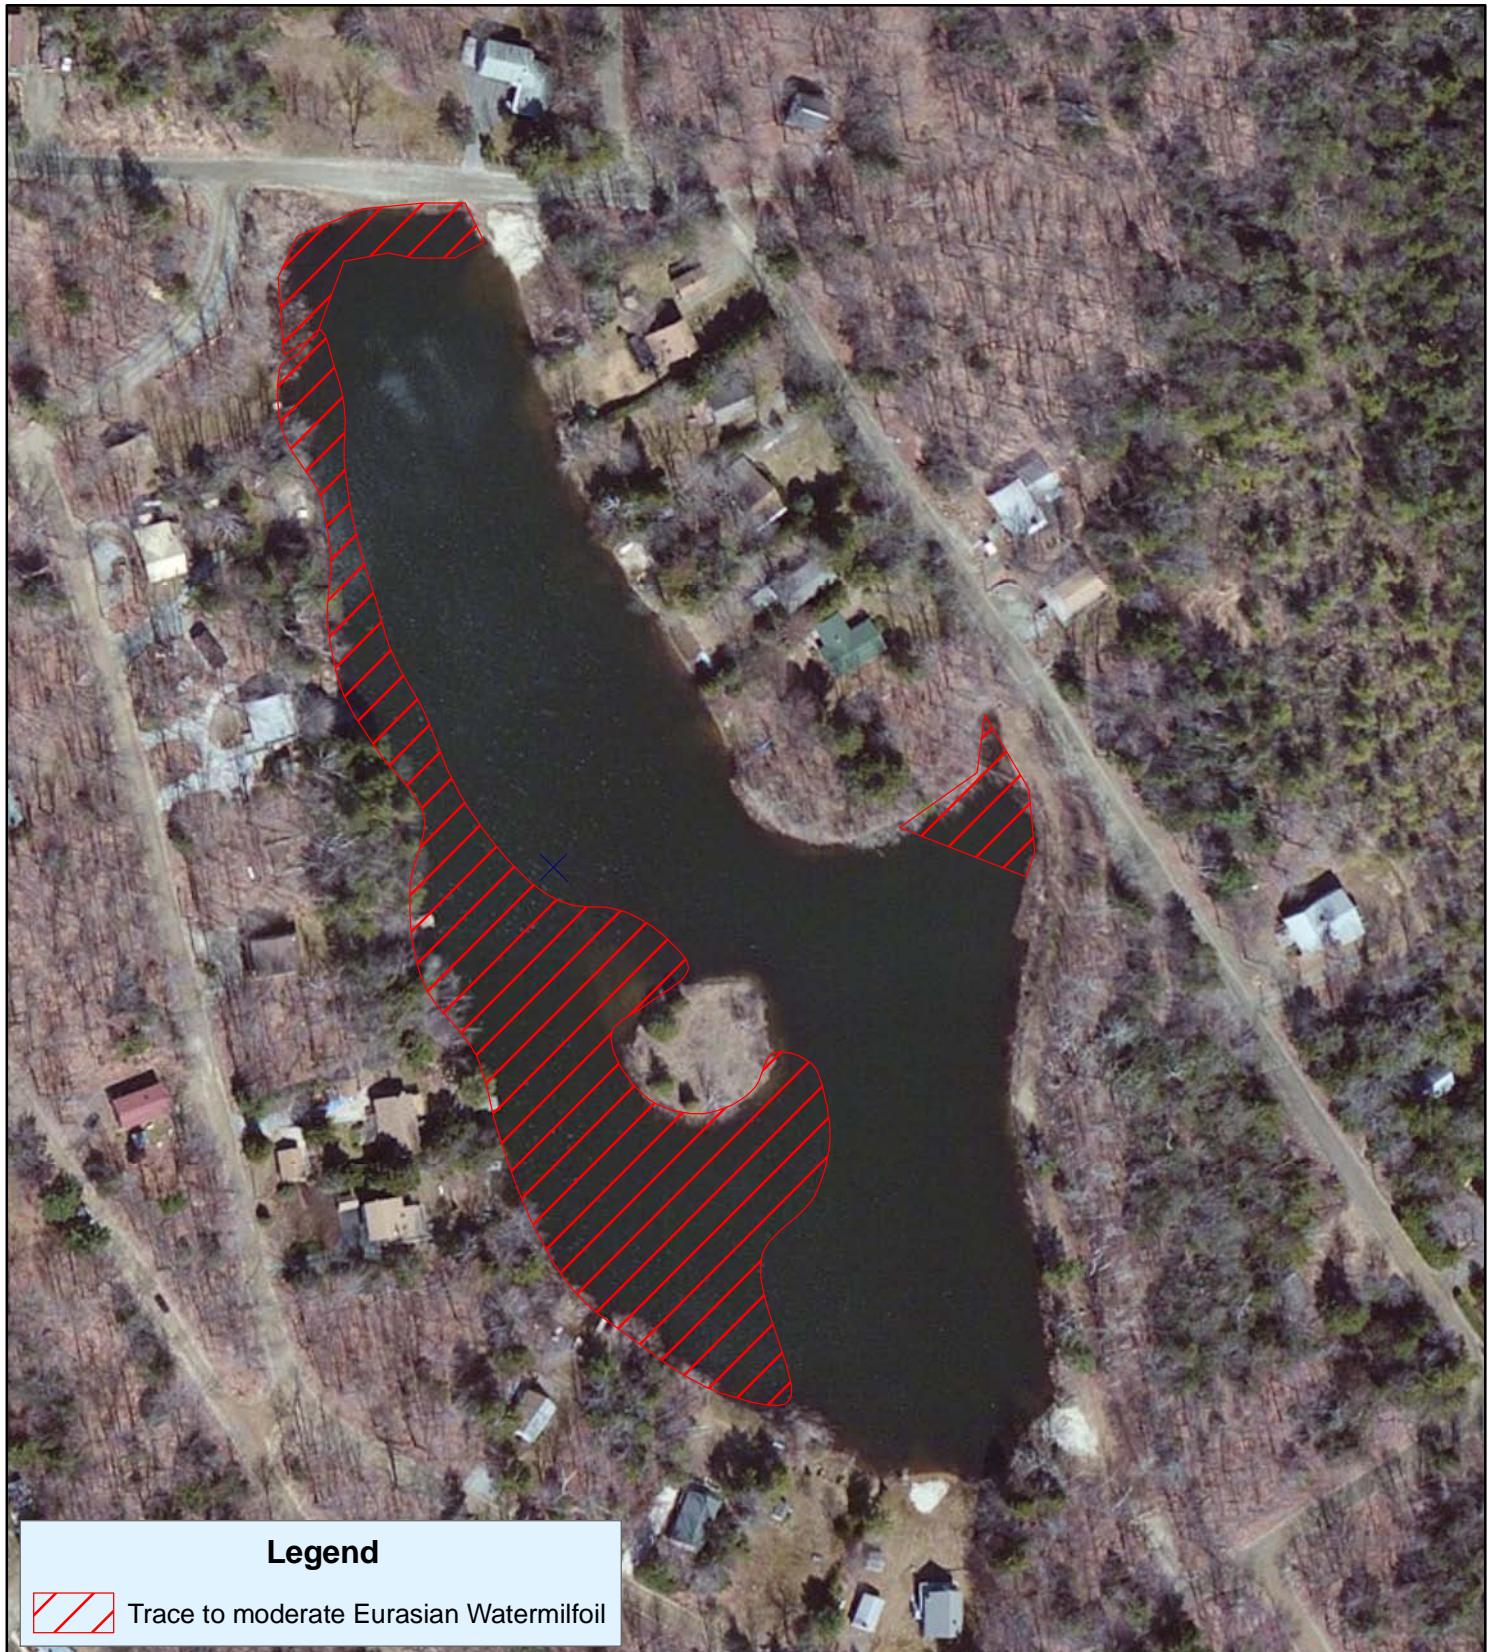
Figure 2: Pre-Management Distribution of Eurasian Watermilfoil
in Lancelot Pond

Pre: Eurasian watermilfoil was observed in several areas of the pond in sparse to moderate density. Bladderwort, large-leaf pondweed, and waterweed were present in moderate density throughout the waterbody.

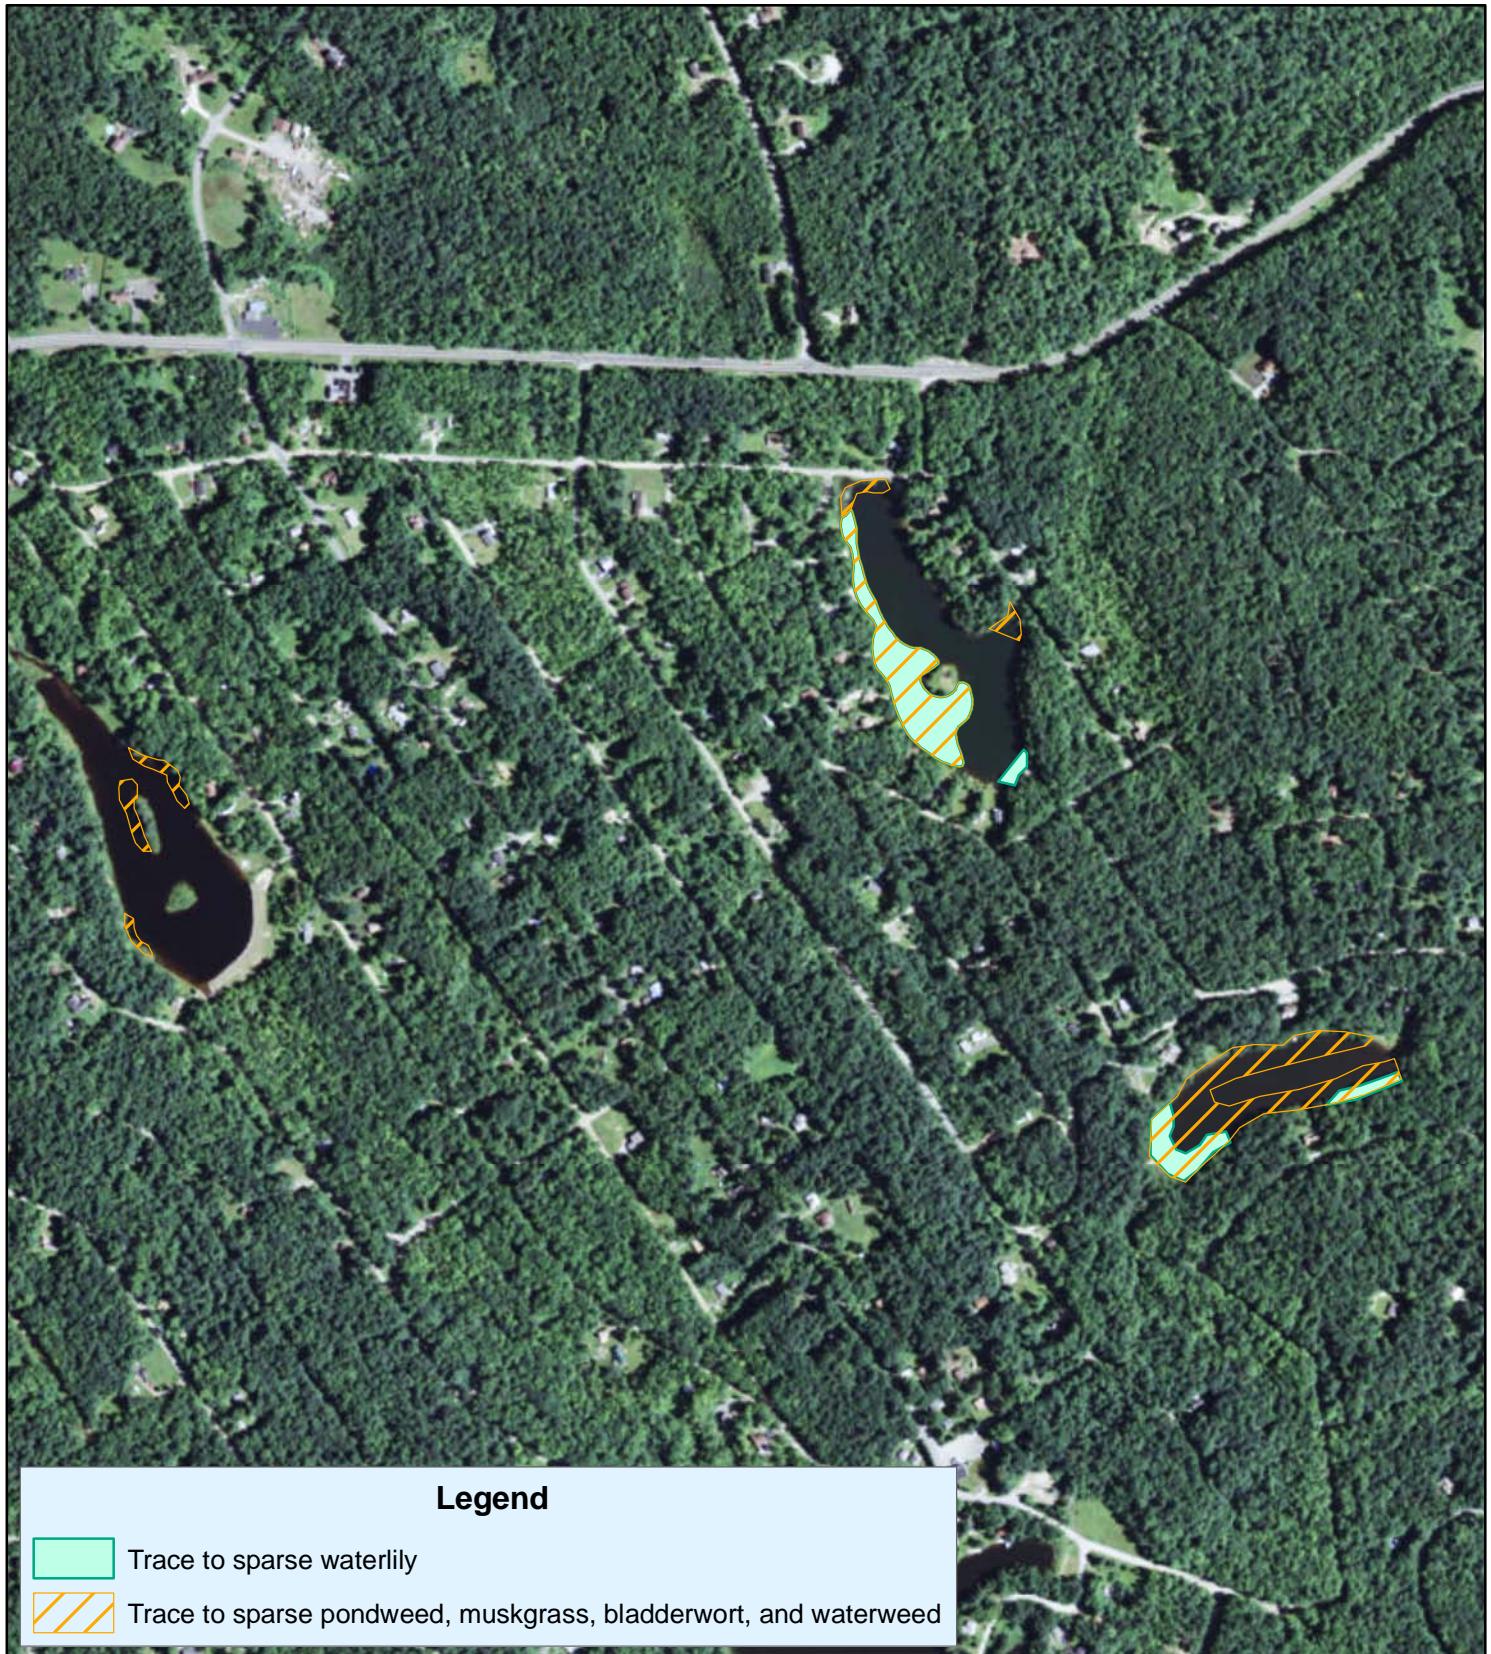
Figure 3: Post-Management Distribution of Aquatic Vegetation in Little Robinhood, Lancelot, and Fawn Ponds

Post: Large-leaf pondweed and muskgrass were the most common species throughout the pond. Watershield and common waterweed were observed in sparse patches along the entire shoreline. Eurasian watermilfoil was not observed during this inspection. The diquat herbicide treatment in June provided excellent results for the summer months.

Post: Similar to the pre-treatment inspection, big-leaf Pondweed, bladderwort, and ribbon-leaf pondweed were present in moderate densities along the shoreline. Macro-algae (chara) was also present in moderate abundances throughout.

Post: Common waterweed, ribbon-leaf pondweed, large-leaf pondweed, slender naiad and watershield were observed around the shoreline of the pond. Bladderwort and chara were the most prevalent species in the pond at the time of the survey, observed at moderate abundances.

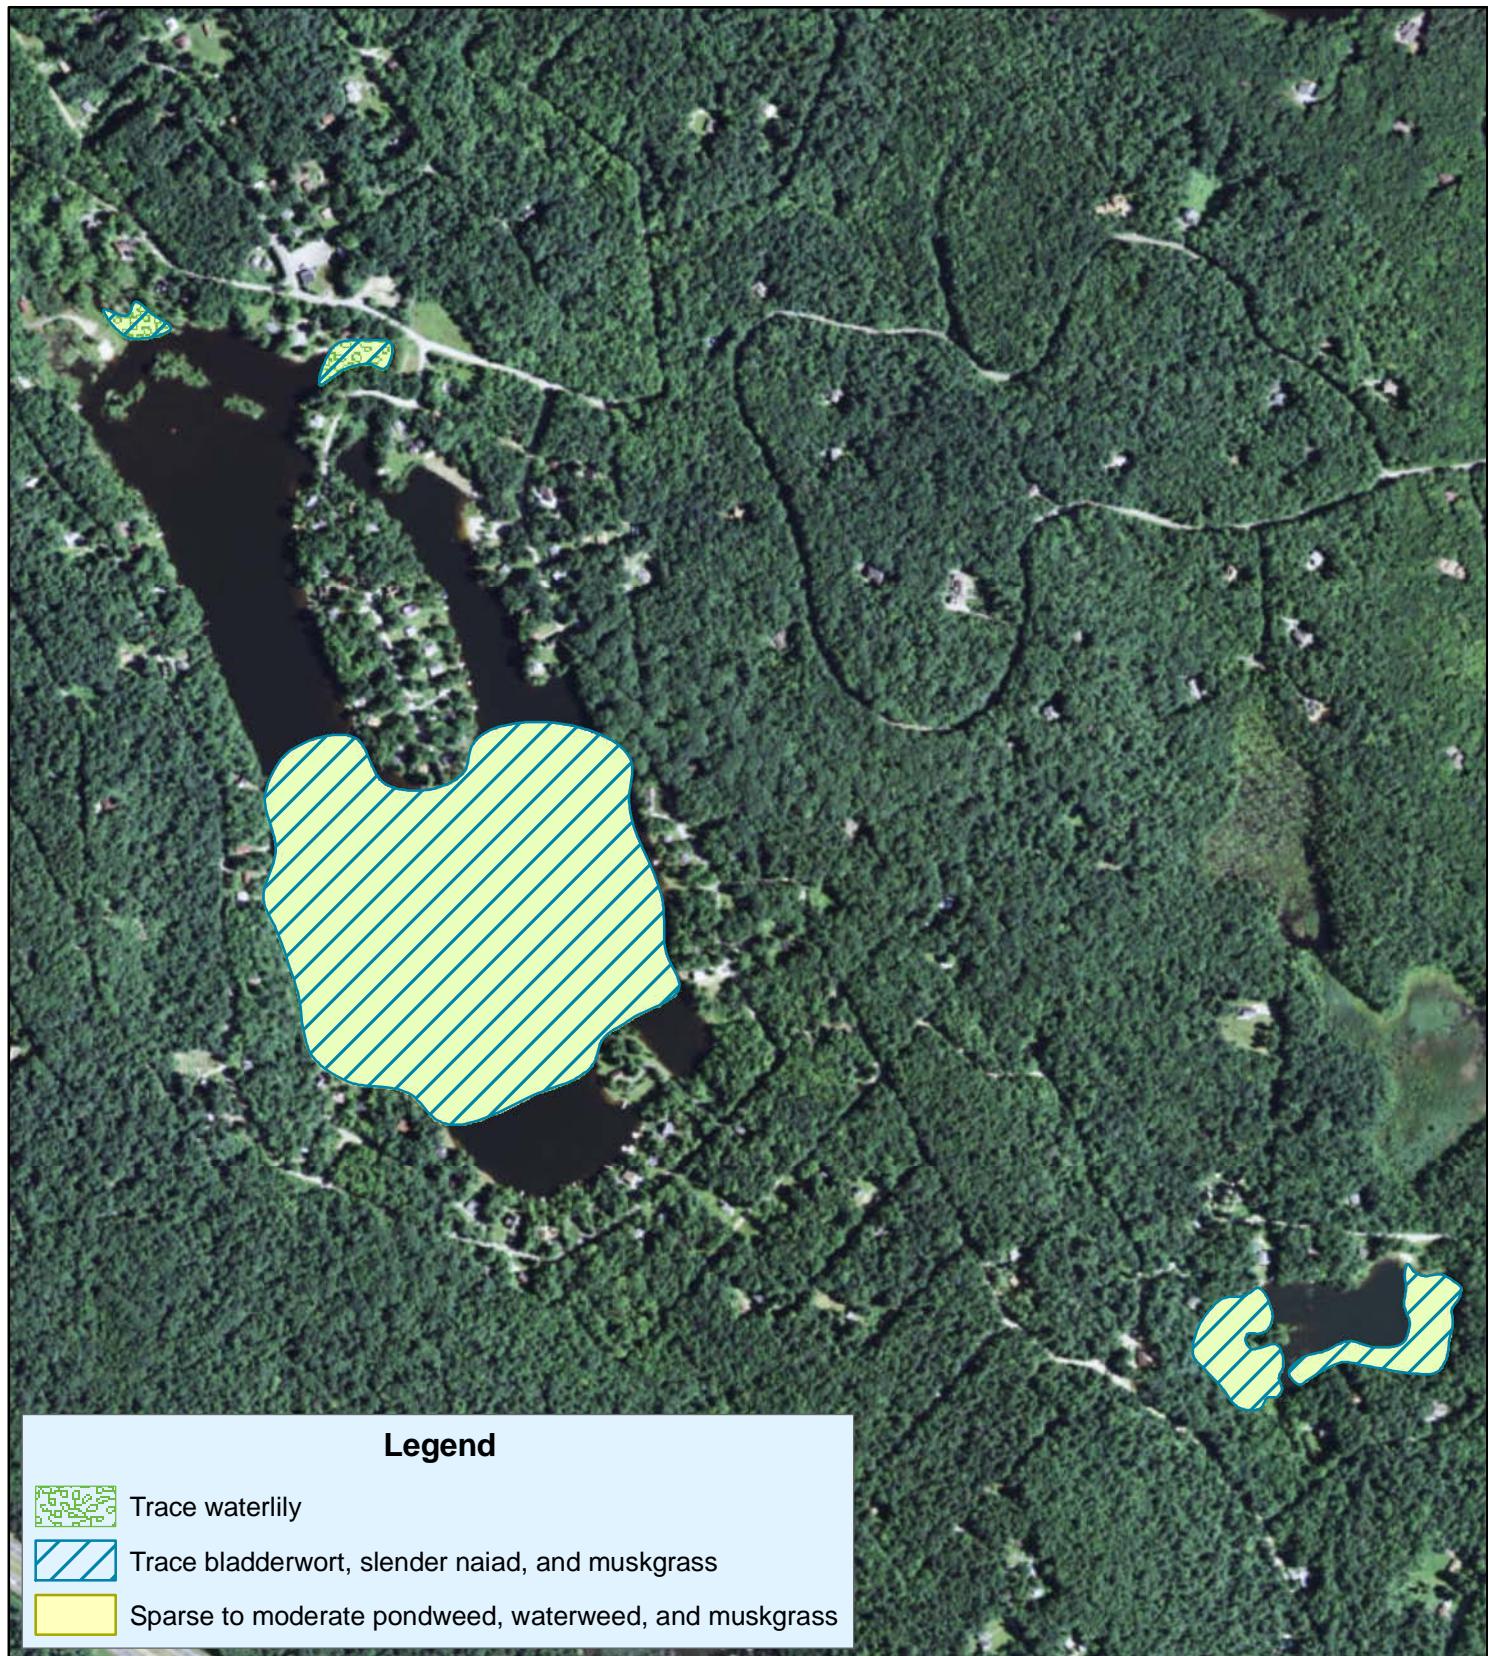
Figure 4: Post-Management Distribution of Aquatic Vegetation in Robinhood and Excalibur Pond

Post: Bladderwort and slender naiad were the most abundant species found and was present in a sparse-moderate density, intermittently throughout the entire pond. Sparse density large-leaf pondweed and ribbon-leaf pondweed were present sporadically in the northern coves and more predominantly in the southern coves. Brittle naiad was not observed during this survey, indicating that the herbicide treatment was successful in managing this invasive species. Low density watershield, the macro-algae muskgrass, and thin-leaf pondweed were also common.

Post: As no treatment events were performed on this lake in the 2018 season, vegetative growth remained consistent with the pre-treatment inspection. There were no occurrences of nuisance vegetation observed during this inspection.

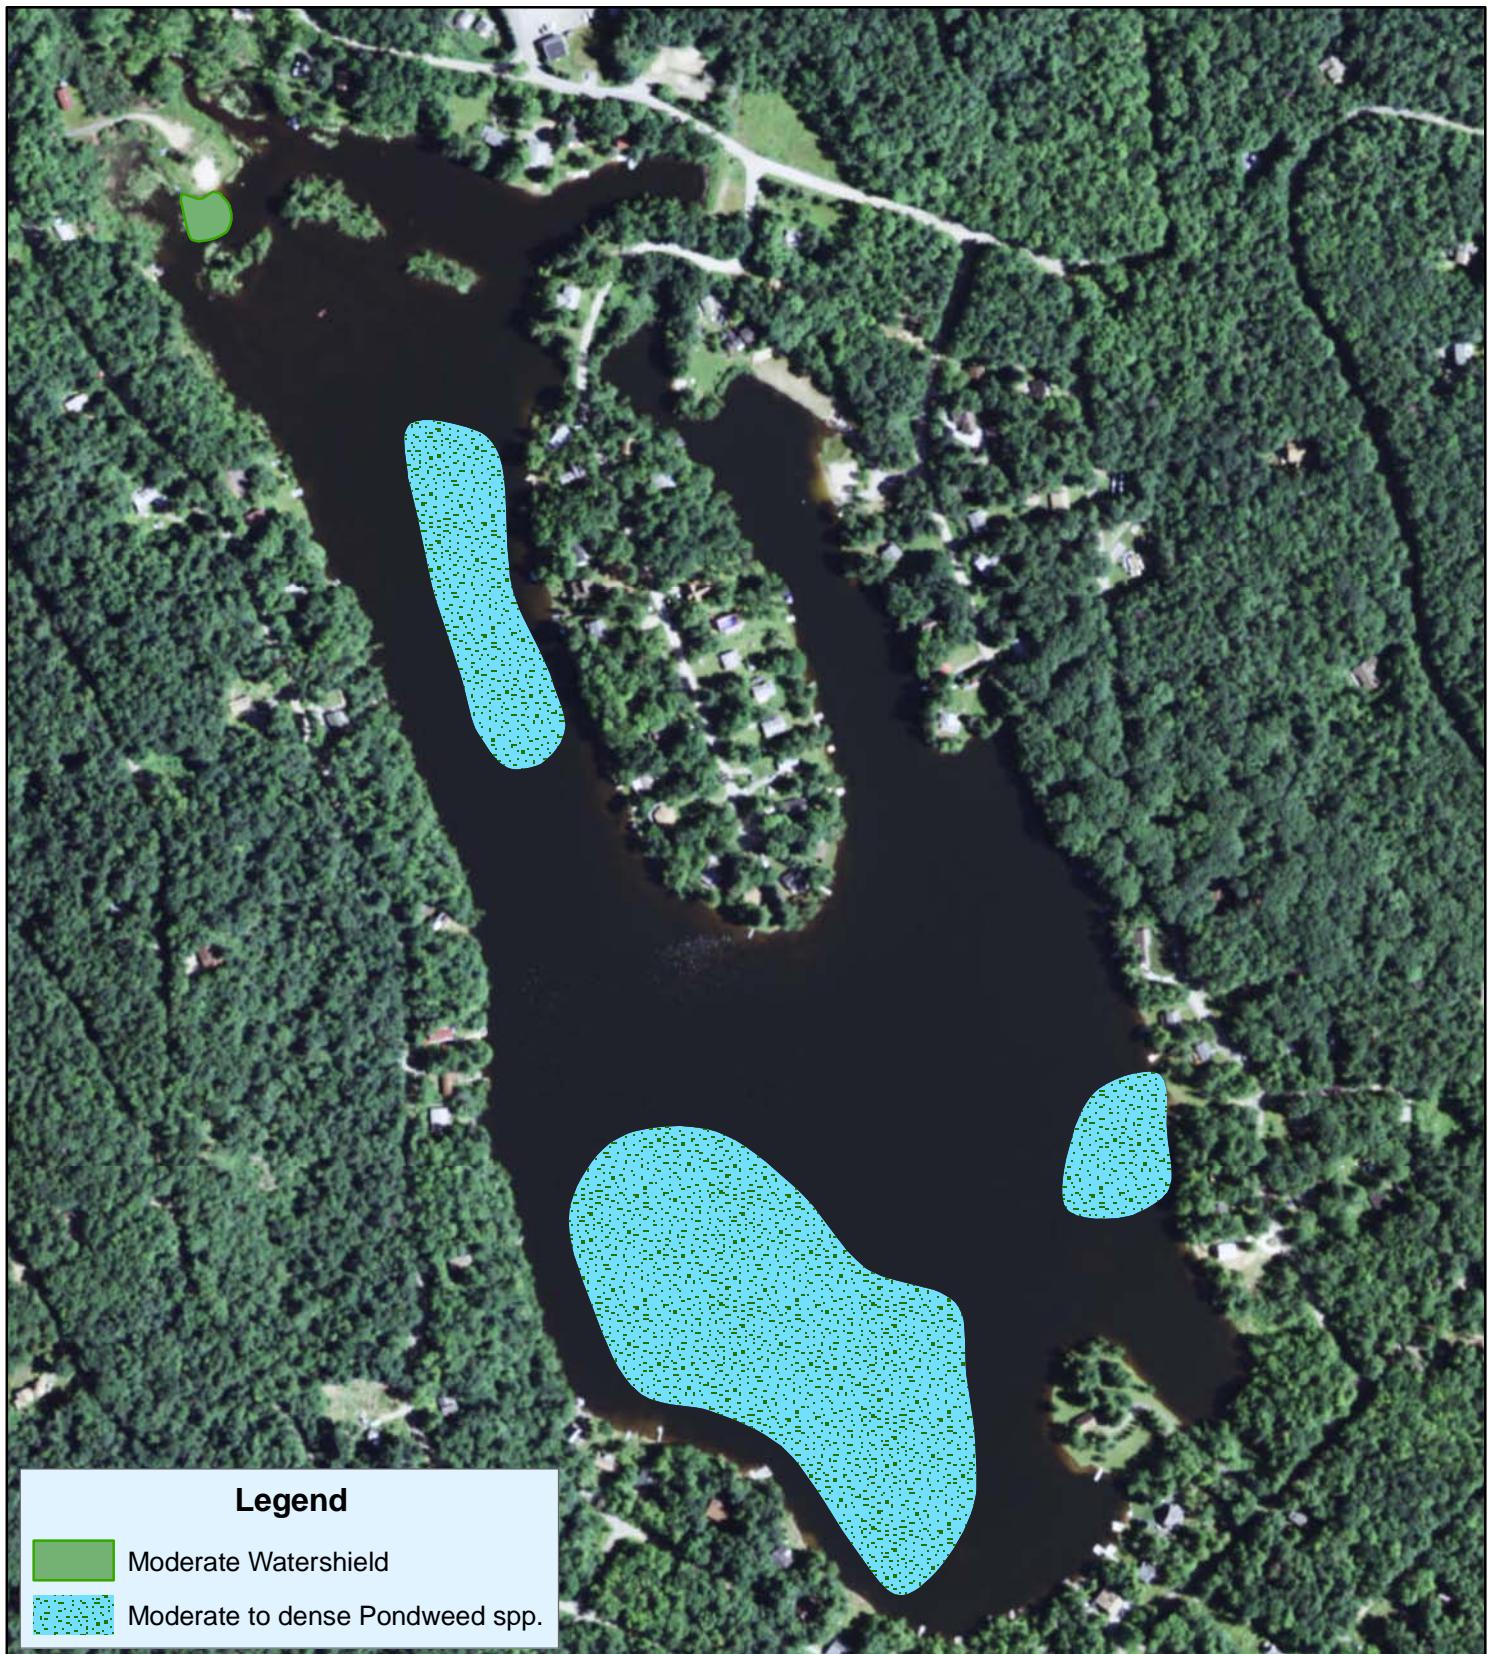
Figure 5: Mechanical Harvesting in Robinhood Pond

In addition to plant monitoring and management, SOLitude has continued supporting local efforts to cut and remove nuisance growth of native plant species with the District's mechanical harvester. In this capacity, SOLitude surveyed Robinhood Lake on July 3 to help identify priority harvesting areas.

Given the amount of the growth observed, target areas were separated by density with respective acreage. Areas with the greatest extent of growth and impact on recreational use were labeled as dense and moderate, while areas with less growth were labeled as sparse and trace. The lesser areas were being targeted after primary locations were managed. (Refer to figure labeled “Figure 5: Robinhood Lake Aquatic Vegetation Harvest Areas”).
